**NATIONAL TRANSPORTATION SAFETY BOARD
OFFICE OF AVIATION SAFETY
WASHINGTON, D.C. 20594**

SYSTEMS GROUP CHAIRMAN'S FACTUAL REPORT

NTSB ID No.: CEN11IA156

Location:	Galliano, Louisiana
Date:	January 19, 2011
Time:	About 1145 Central Standard Time (CST)
Aircraft:	Sikorsky S-92A
Registration Number:	N920AL

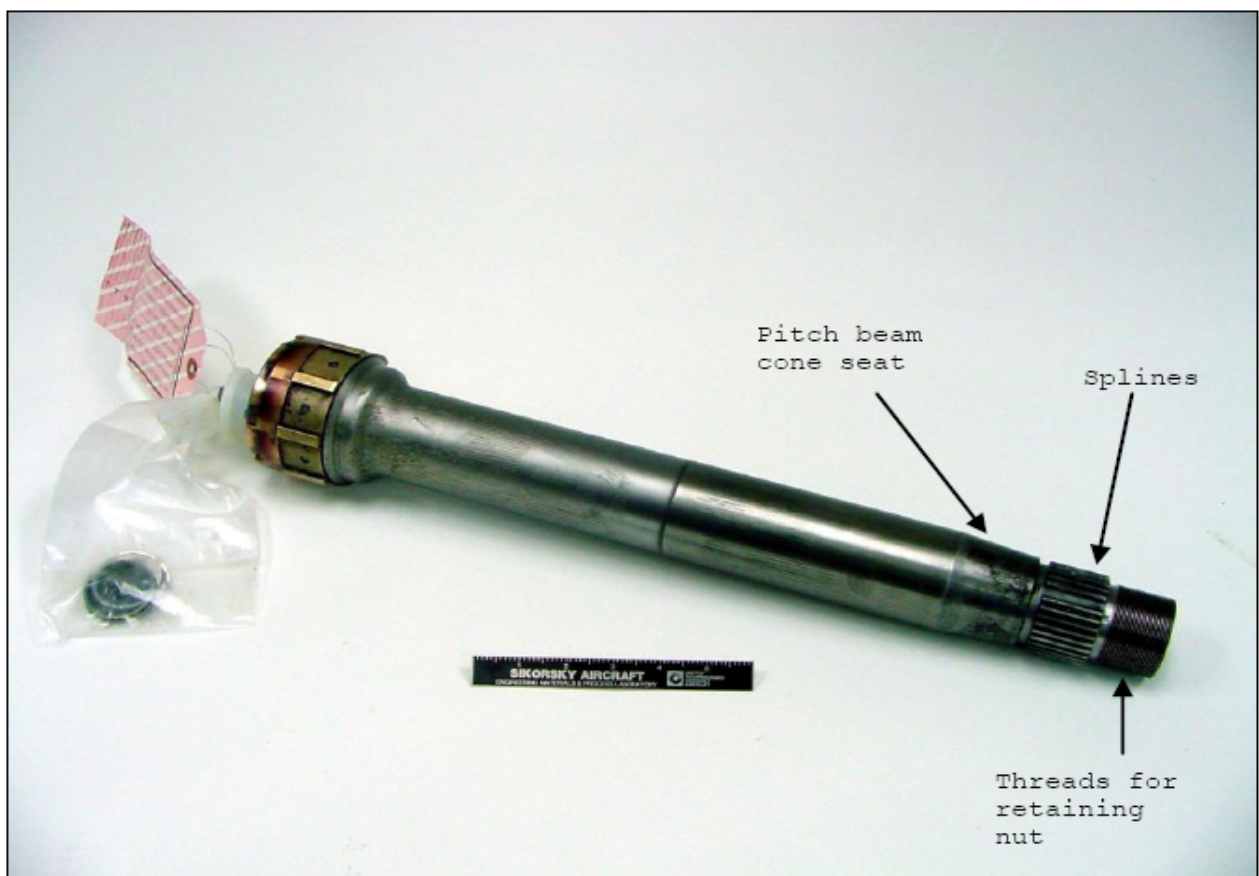
Figure 2 As-received pitch change shaft

The pitch change shaft part number 92358-06303-041, serial number B063-00156 was examined at the Sikorsky Aircraft Company Materials and Processes laboratory. Refer to figure 2 for a photograph of the pitch change shaft after it was removed from the helicopter.

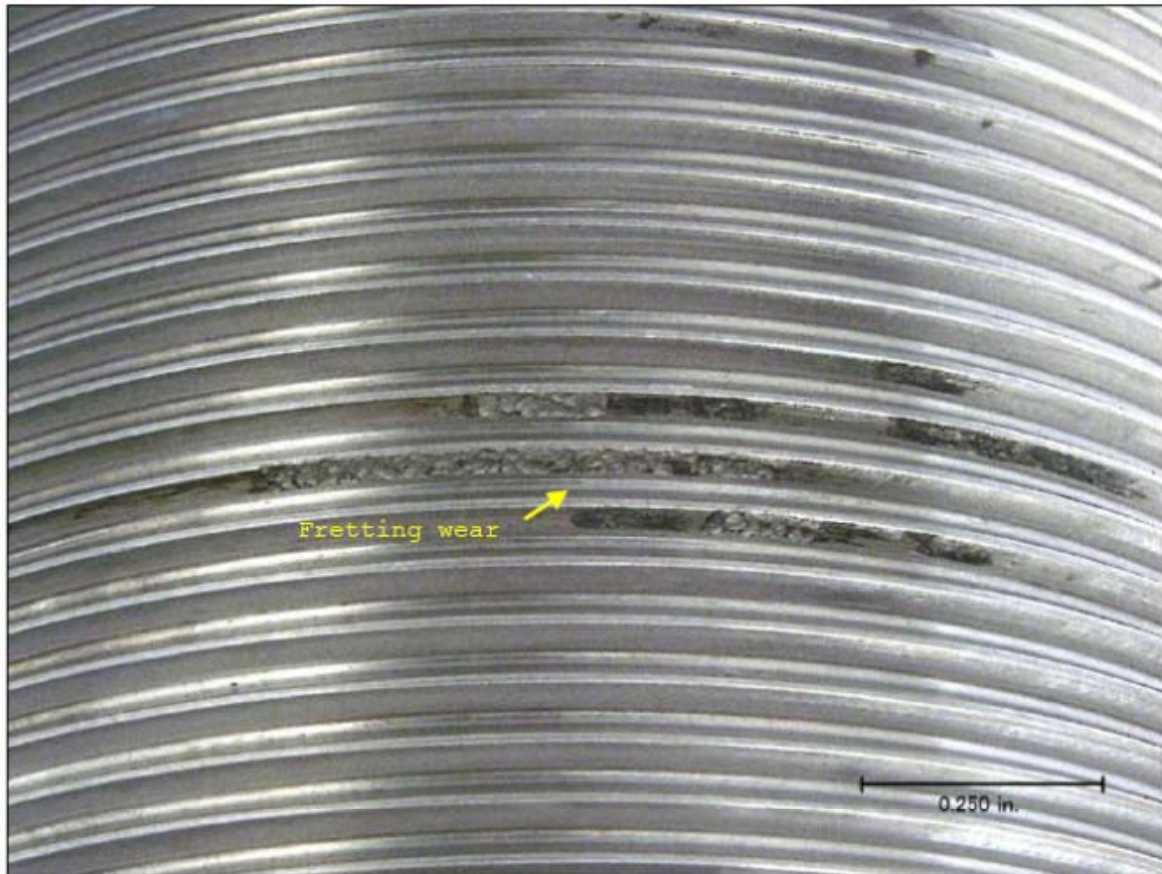
A magnetic particle inspection (MPI) on the pitch change shaft did not reveal any cracks. The threads of the pitch change shaft appeared to be in good shape with the exception of a few threads with evidence of fretting wear (Figure 3) on the engaging surfaces. Dimensional inspection of the threads showed that the locations without fretting damage met the required drawing specifications.

Figure 3 Pitch change shaft - fretting wear on threads

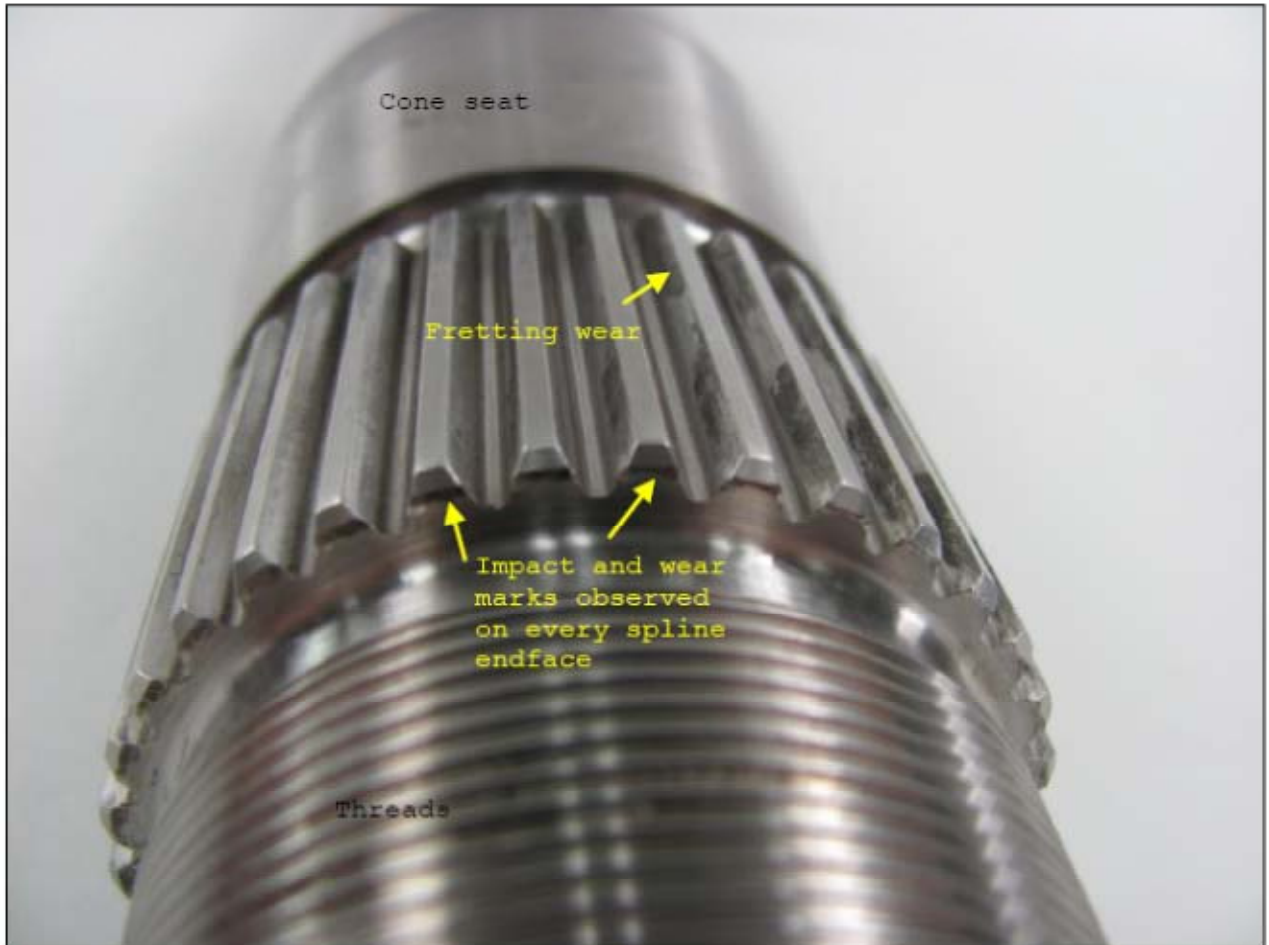
Plastic deformation marks (consistent with the shape of the washer splines) were observed on the end faces of all of the pitch change shaft splines. Refer to figure 4. Adjacent to the compressed spline outlines were wear marks.

Figure 4 Pitch change shaft - impact marks on spline end face

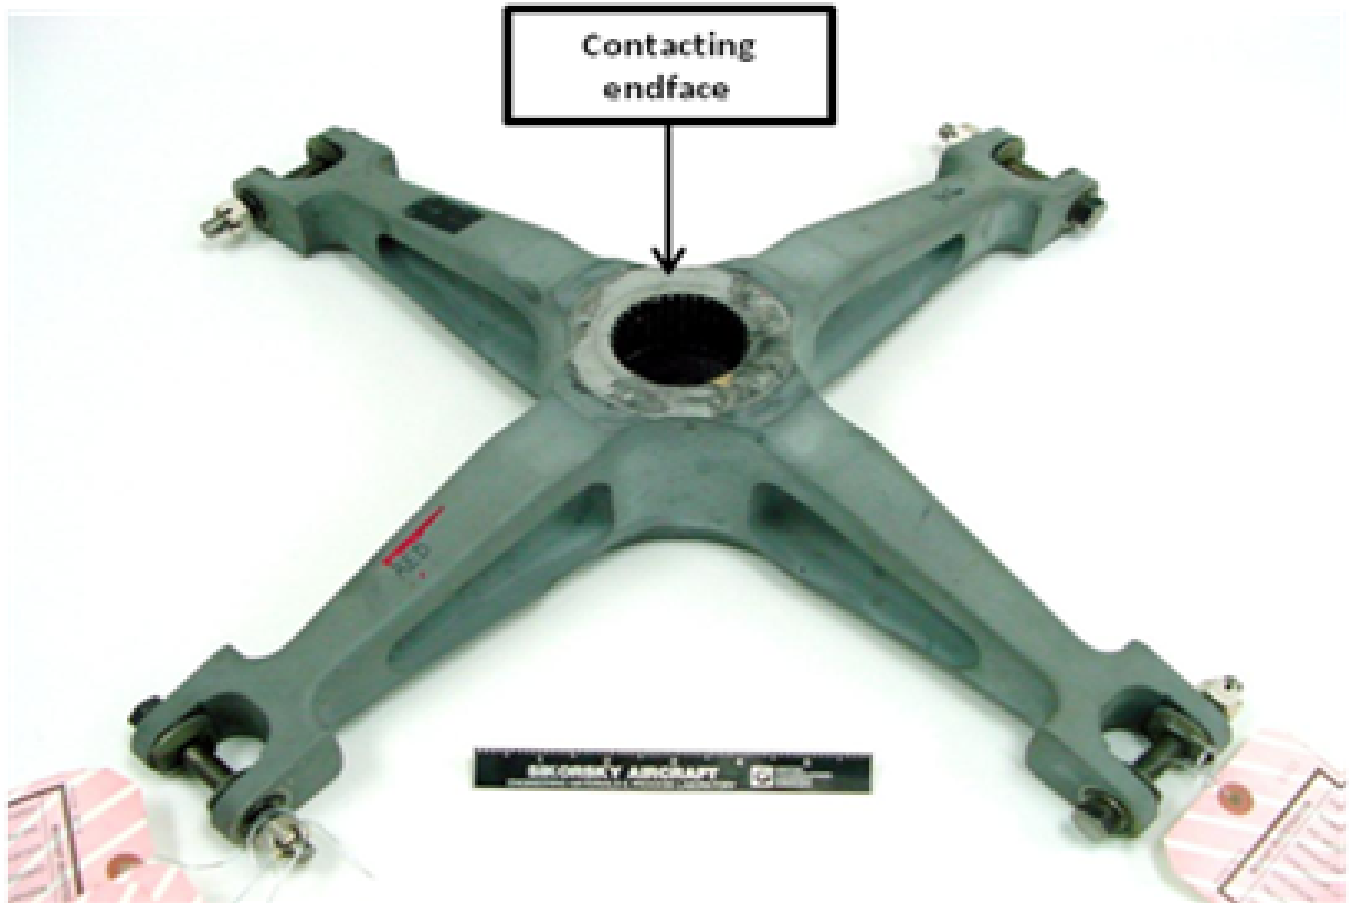
Figure 5 Pitch Beam Assembly

A cursory visual examination of the pitch beam assembly (Figure 5) revealed witness marks (which appear to be consistent with imprints of spline teeth) within the inner diameter of the component.

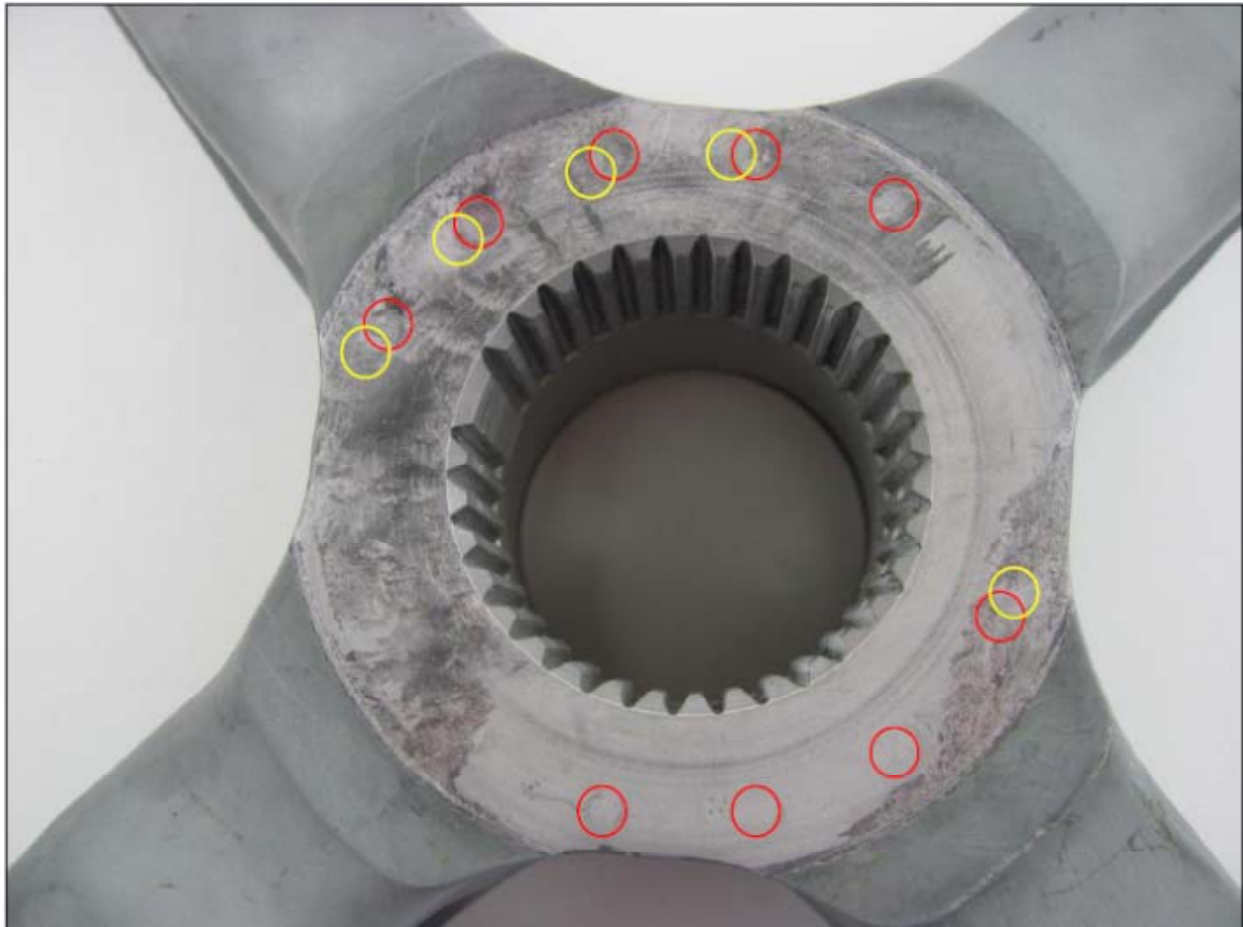
Two sets of witness marks from the screw holes of the missing pitch beam lock washer were visually observed on the contacting end face of the pitch beam assembly. Refer to figure 6.

Figure 6 Witness marks on the pitch beam assembly

An exemplar pitch beam lock washer was placed in contact with the pitch beam and the two sets of witness marks independently lined up with the holes in the washer. In both configurations the large tooth of the washer and the large tooth of the pitch beam did not line up. The evidence of the witness marks along with the plastic deformation on the end faces of the pitch change shaft splines is consistent with the locking washer installed with its indexing spline slightly off, resulting in a cocking condition and incomplete engagement of the spline teeth.
